Peatland restoration in Iceland

how to speed up establishment of peatland vegetation in disturbed areas following restoration?

Ágústa Helgadóttir, Sunna Áskelsdóttir & Ölvir Styrmisson
Soil Conservation Service of Iceland
agusta@land.is

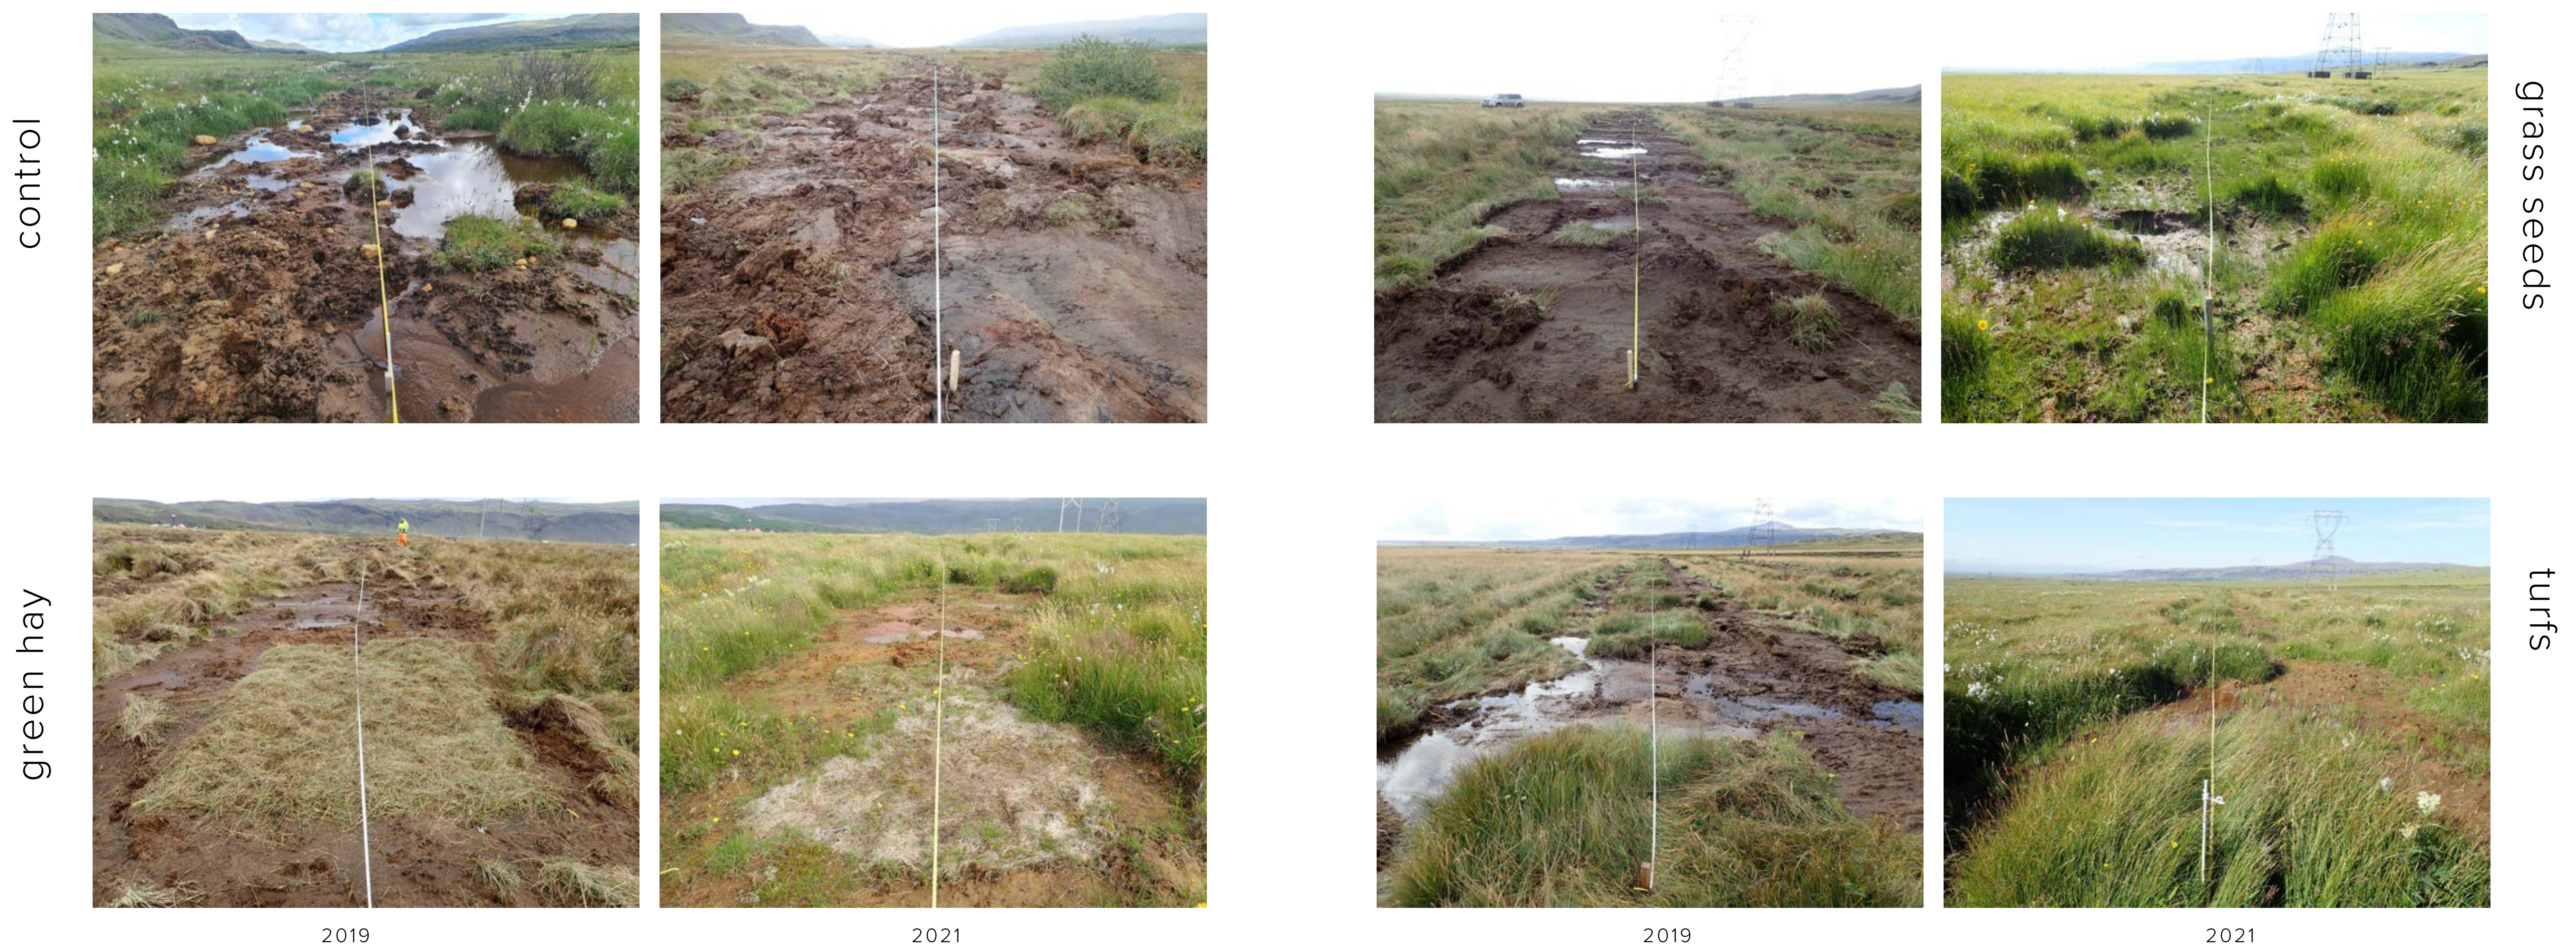
Drone image of restored peatland in Sogn S-Iceland, June 2021
